**City of Kingston  
Report to Council  
Report Number 16-183**

**To:** Mayor and Members of Council  
**From:** Lanie Hurdle, Commissioner, Community Services  
**Resource Staff:** Paige Agnew, Director, Planning, Building & Licensing Services  
**Date of Meeting:** June 21, 2016  
**Subject:** Application for Heritage Permit  
**Address:** 53 King Street East (P18-177)  
**File Number:** P18-030-2016

Re. 53 King St. East Masonry Repairs

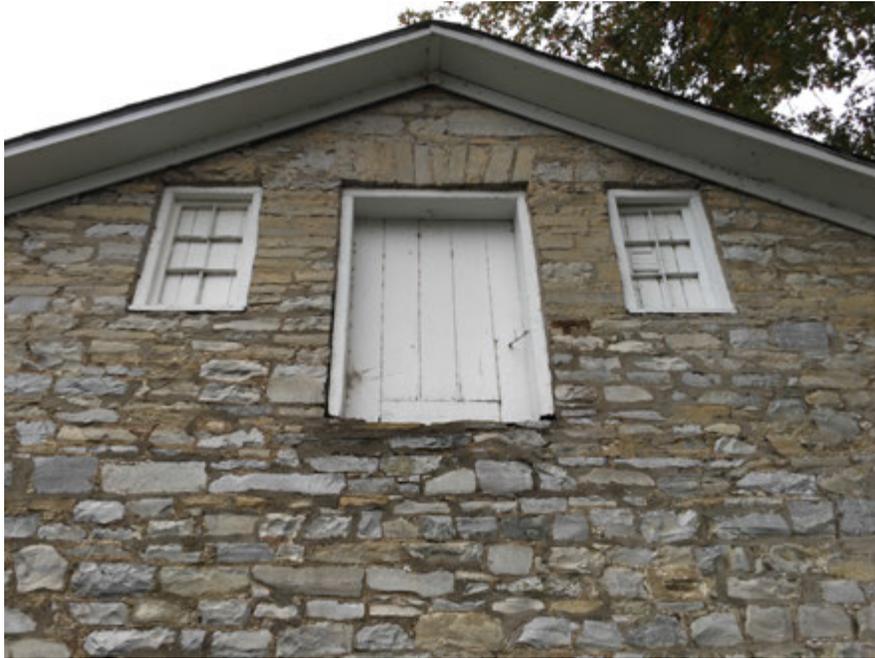
The stonework on the East wall is similar in condition to that of the South, with the exception that there is evidence of more cement-based repointing (see the dark grey mortar pictured below). This is likely a result of water infiltration through the openings in the top section of wall which has migrated downward through the wall and caused erosion in the mortar joints. Another factor is likely exposure to wind driven rain from the lake to the South.

*The dark grey mortar joints are indicative of cement-based repointing which has low rates of permeability, and is excessively hard. In contrast, the buff coloured mortar pictured on the South wall is the original lime mortar pointing.*

Removal of the cement-based pointing should be the priority on the East wall. This would be done through repointing with a suitable lime-based mortar. Also, three openings require sealant around their perimeter, and the base of each opening should be sealed to ensure that water is not able to migrate into the wall at these locations.

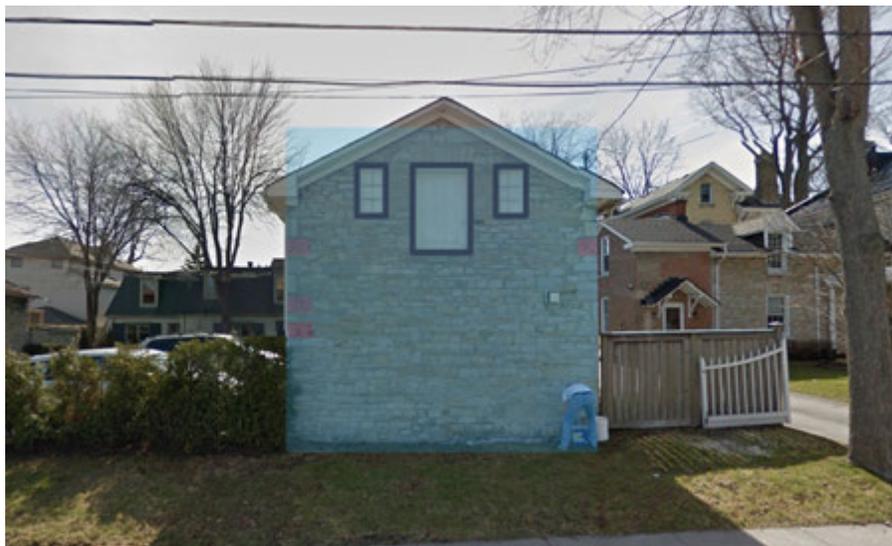
*Areas in red represent existing Limestone quoins that are in need of replacement. (East elevation)*

There are four quoins (cornerstones) in the wall that are entering an advanced stage of deterioration. Unfortunately there is nothing that can be done at this point to repair these structural stones, and they should be replaced with new pieces of Kingston Limestone.

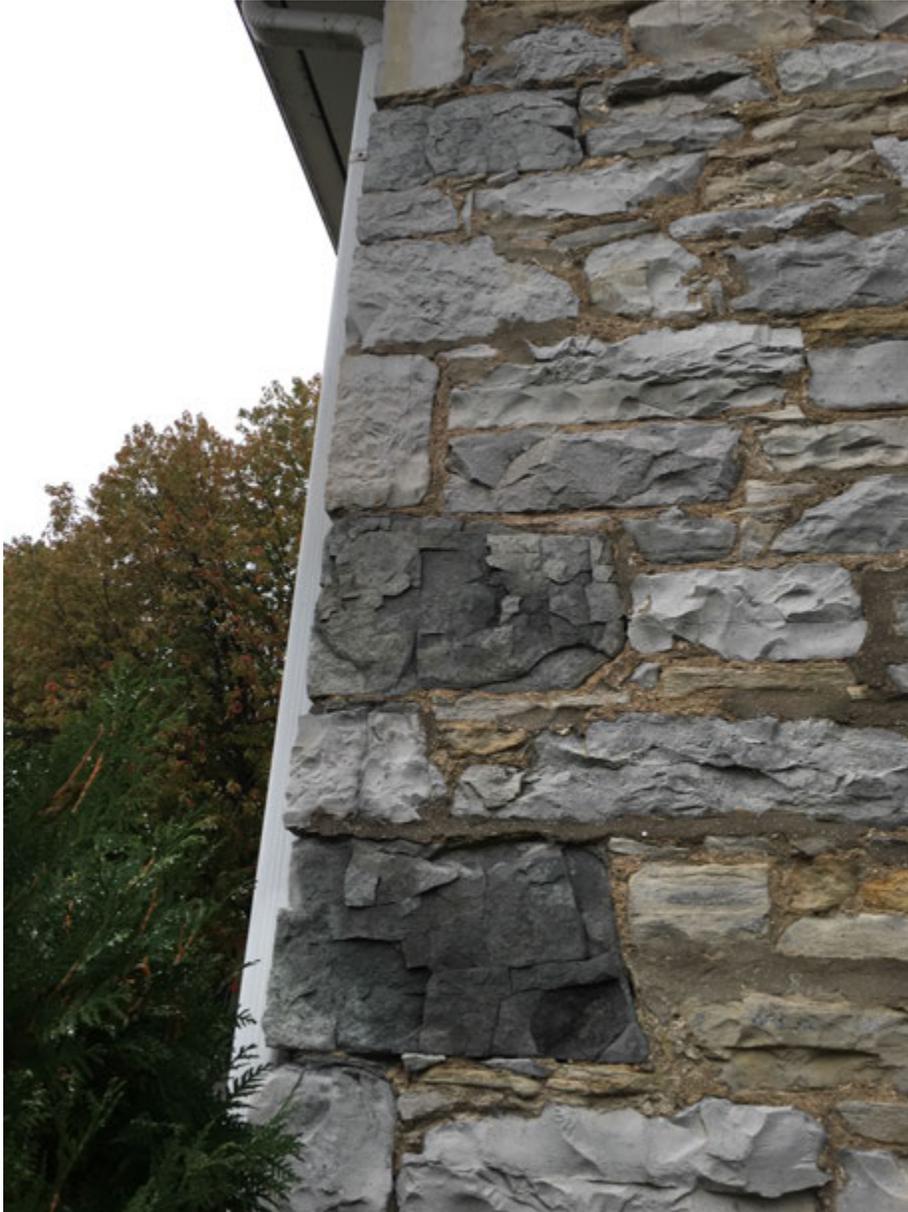
*Four quoins on the East wall are in need of replacement. Multiple fractures and spalling stone can be observed in these locations.*
