**City of Kingston
Report to Council
Report Number 16-167**

To: Mayor and Members of Council
From: Lanie Hurdle, Commissioner, Community Services
Resource Staff: Paige Agnew, Director, Planning, Building & Licensing Services
Date of Meeting: June 21, 2016
Subject: Application for Heritage Permit
Address: 171 Bagot Street
File Number: P18-1003-037-2016

MASONRY REPAIRS to 171 Bagot St, Kingston, ON, K7L 3E9

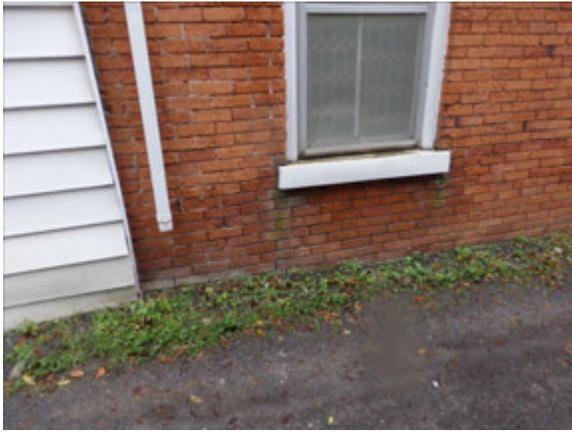
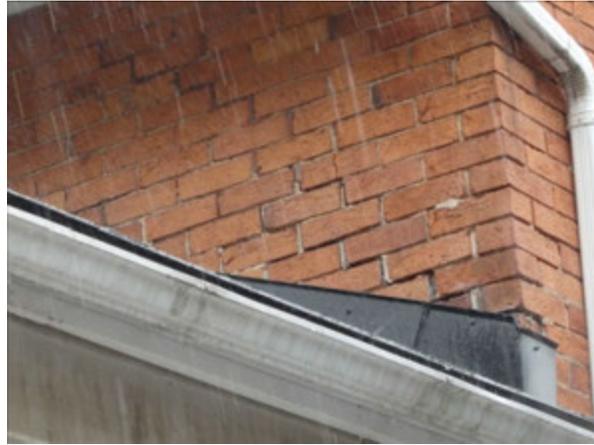
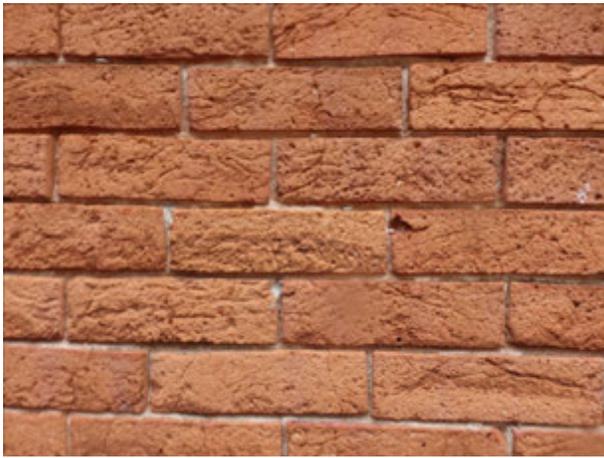
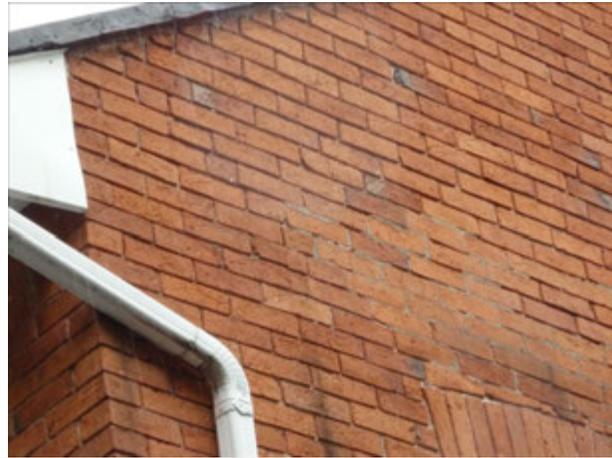
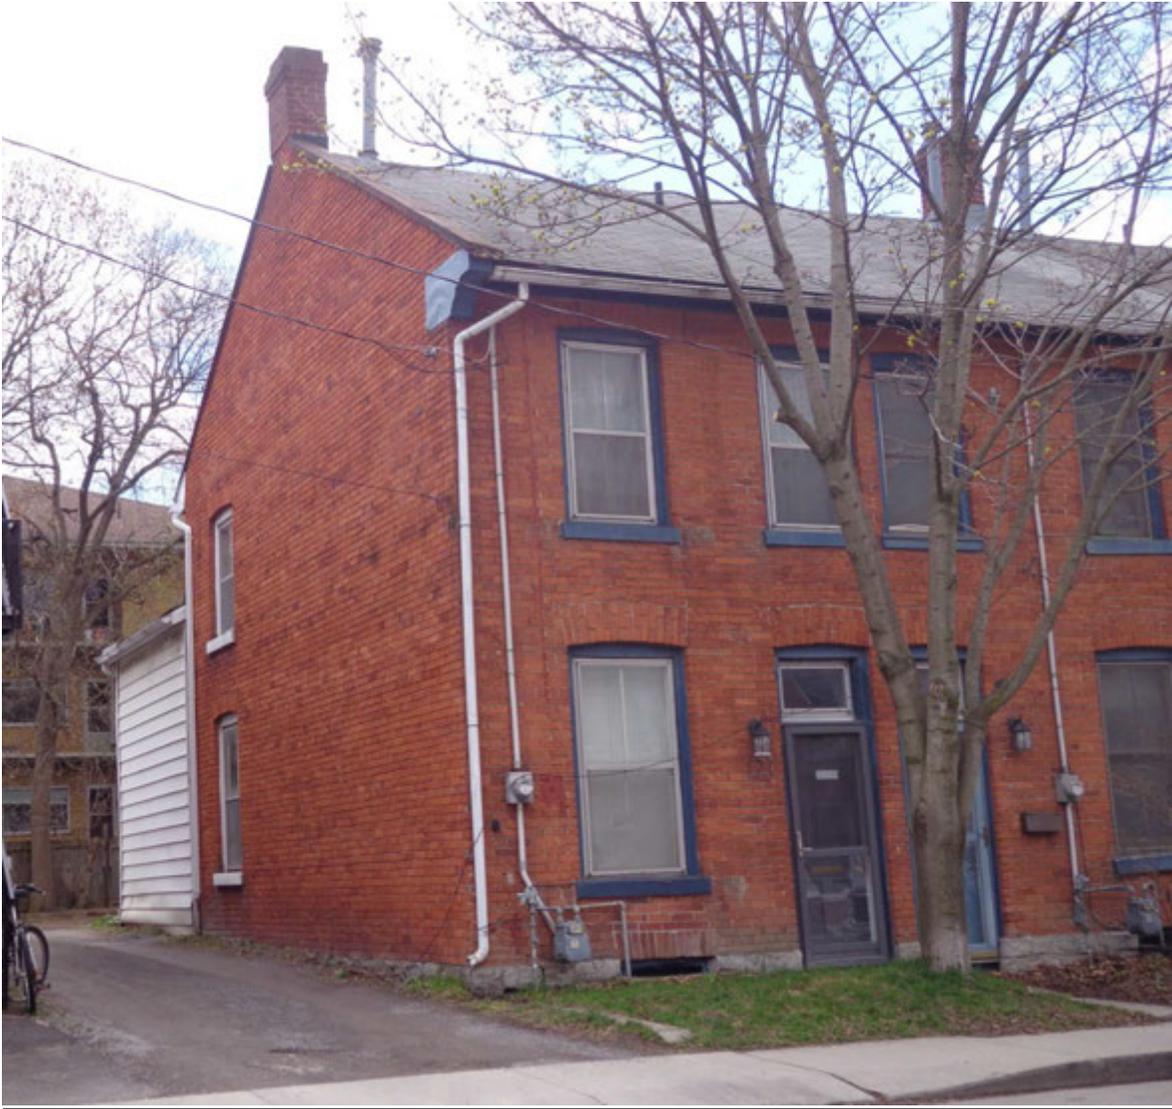
Photographs of 171 Bagot Street

Brick Re-Pointing: Deteriorated mortar joints are to be removed and re-pointed using a lime based mortar and colour additives, if required, to match the surrounding mortar as close as possible. The areas being re-pointed are as follows:

- 15 sq/ft between upper two windows on front wall, 10 sq/ft over roof on back wall
- 100% (712 sq/ft) on the side wall

Brick Replacement: Deteriorated brick are to be removed and replaced with quality reclaimed brick, chosen to match the existing brick in colour and texture, as close as possible. The areas of replacement are as follows:

- 15 brick below chimney on side wall, 20 brick bottom right corner of side wall

Stone Pointing: Deteriorated mortar joints are to be cut out to a minimum of twice the depth or the mortar joint or until sound mortar is found. The joint is then re-pointed using a lime based mortar and colour additives, if required, to match the surrounding mortar, as close as possible. The areas of stone re-pointing are as follows:

- 4 sq/ft on bottom left corner of the front foundation, 4 sq/ft between doors on the front foundation
